Case report

Break in the lag: A unique mode of failure of TFNA® lag screw in an intertrochanteric fracture non-union

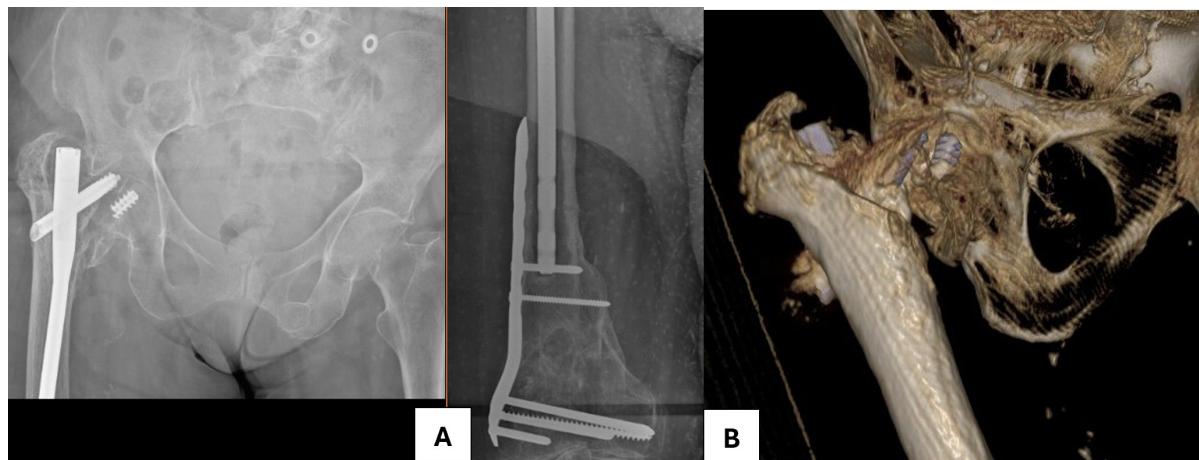
A nonagenarian (91 years-old) lady was brought in by ambulance with a history of unwitnessed fall at home after tripping over followed by pain in her Right hip and inability to weight bear. X-rays (**Fig 1a**) confirmed an implant failure of the cephalic fenestrated portion in the lag screw of the TFNA implant in the backdrop of possible non-union of previously sustained pertrochanteric fracture and proximal migration of femur with broken part of the screw inside the joint. Clinical examination revealed that the patient was unable to do an active straight leg raise on the side and movements around the hip elicited pain. She mentioned of having aching pain along her hip and thigh for the last 2-3 months and gradually worsening mobility. Following her index surgery (done at a nearby tertiary care hospital), she was able to walk indoors with the help a frame until recently but did not go outside and relied on family and carers for day-to-day activities. A CT scan (**Fig 1b**) was done that confirmed the non-union with loss of fixation and breakage of the lag screw that appeared to have failed through the fenestrated threads. The intraarticular broken part of screw had been eroding the acetabulum leaving a defect in the superolateral dome.

Figure 1: A) X-rays showing Broken lag screw of TFNA with non-union (AP of the pelvis with hips and AP of distal femur). B) CT scan confirming non-union with the broken screw seen eroding the acetabulum.

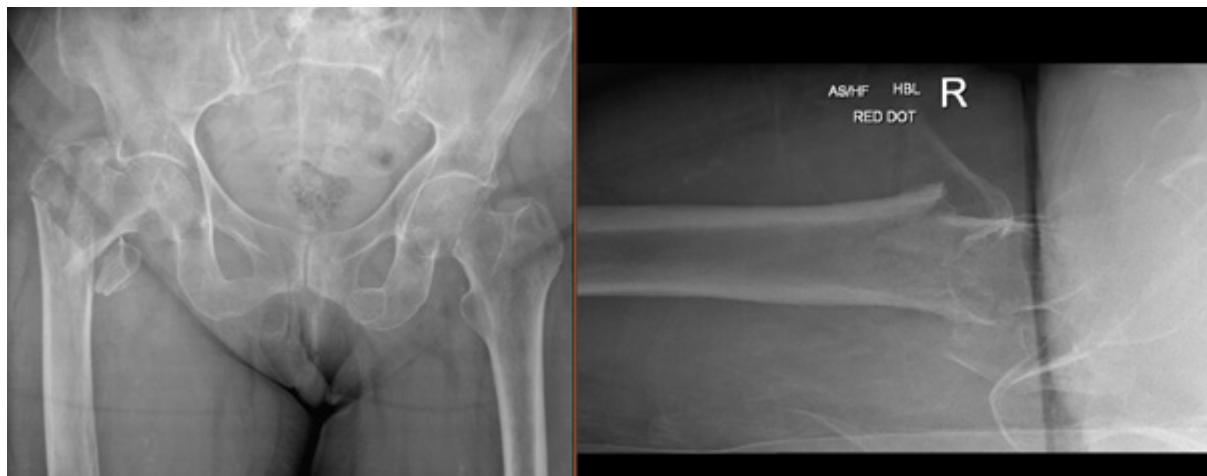
11 months back she sustained an intertrochanteric fracture of the Right femur (AO/OTA 31-A2.2) (**Fig 2**) fracture of the femur extending to just below the lesser trochanter following a fall from standing height and underwent closed reduction and long TFNA fixation at a different hospital. On reviewing the intraoperative images (**Fig 3**) and notes, it was noted that on account of a pre-existing distal femur locking plate (for an old united distal femur fracture) the surgeons were unable to fix distal locking screws through the nail due to plate position. This was concluded with only proximal lag screw abandoning distal fixation, to avoid further complications from pro-

Figure 2: X-rays of the initial Intertrochanteric fracture of the Right femur (AP and lateral views).

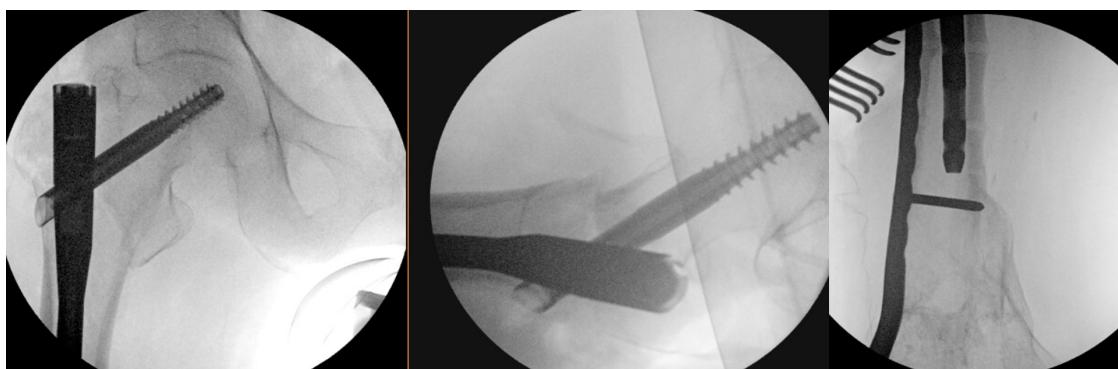
Figure 3: Intraoperative fluoroscopy images of the index surgery - AP and Lateral of Right hip, AP of distal femur.

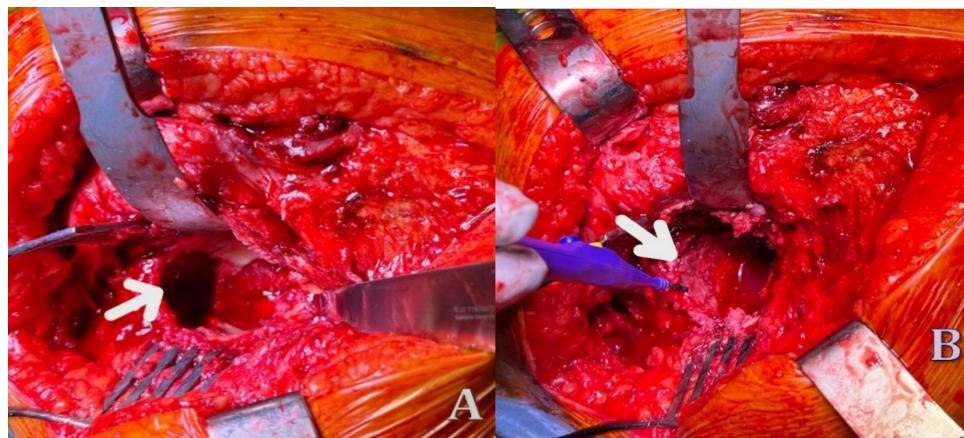
Figure 4: Intraoperative clinical images of the acetabular defect (A- before, B- after bone grafting).

Following a local multidisciplinary discussion involving hip surgeons, orthogeriatric medical team, patient and family members, she underwent a revision surgery for removal of the broken implant, a dual mobility total hip replacement and bone grafting for the acetabular defect (**Fig 4**). Inspection of the explanted hardware confirmed the unusual failure pattern (**Fig 5**) through the threaded region.

In this patient, a salvage dual mobility total hip replacement was done (**fig 7**) with an uncemented cup and a cemented stem after explantation of the nail and broken screw. The acetabular defect was deemed to be contained and addressed with bone grafting from freeze-dried femoral head allograft (**fig 4**). The option of dual mobility cup was decided in view of the poor functioning abductors to reduce any chances of dislocation and further morbidity. Criticism could be raised as to why a longer diaphyseal fitting revision stem was not considered that could avoid stress risers and further fractures of the femur shaft. The rationale behind this complex consideration was to avoid a scenario where a long diaphyseal stem could lead to abutment of the already thinned out distal femoral cortices (from the tip of the IM nail) and

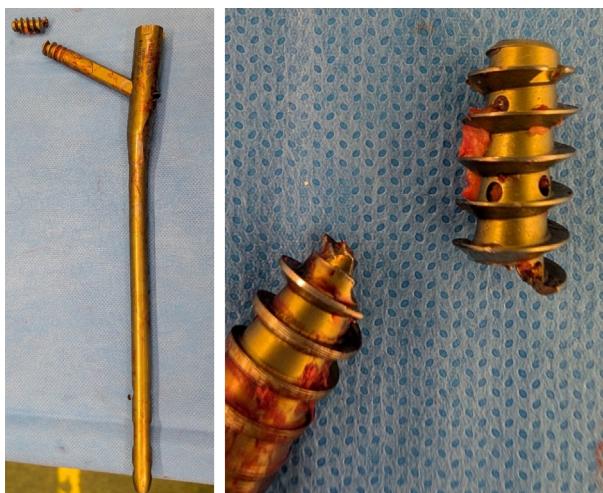
Figure 5: Explanted implant showing break through the thread fenestrations.

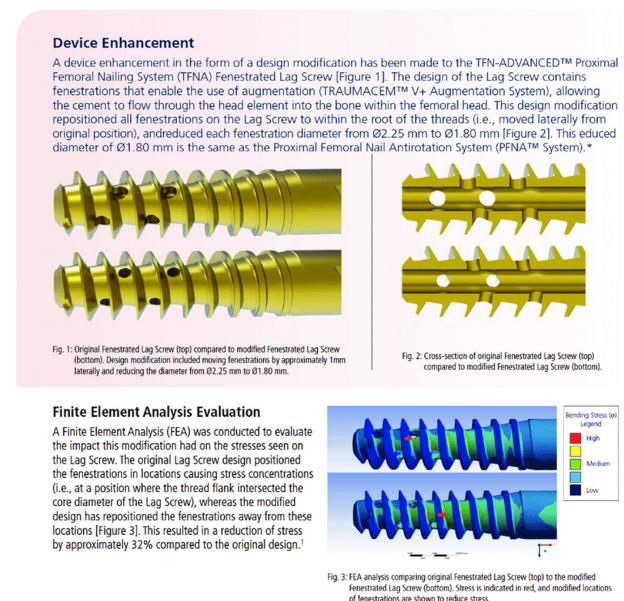
Figure 6: Description of the design changes in the lag screw of TFNA (provided by DePuy-Synthes).

we understand this was discussed with the manufacturer, DePuy-Synthes has made some design improvements to the lag screw to improve fatigue strength (**fig 6**). It is not clear whether the new design fenestrated lag screw was used in the index surgery or an older one, because of the fact that the surgery was done at a different hospital and confidentiality clauses forbid sharing of these details. Irrespective of this, as a learning from this case, it has been agreed to stock solid non-fenestrated screws at out hospital and to use fenestrated ones only when cement augmentation is planned if indicated on a case-to-case basis.

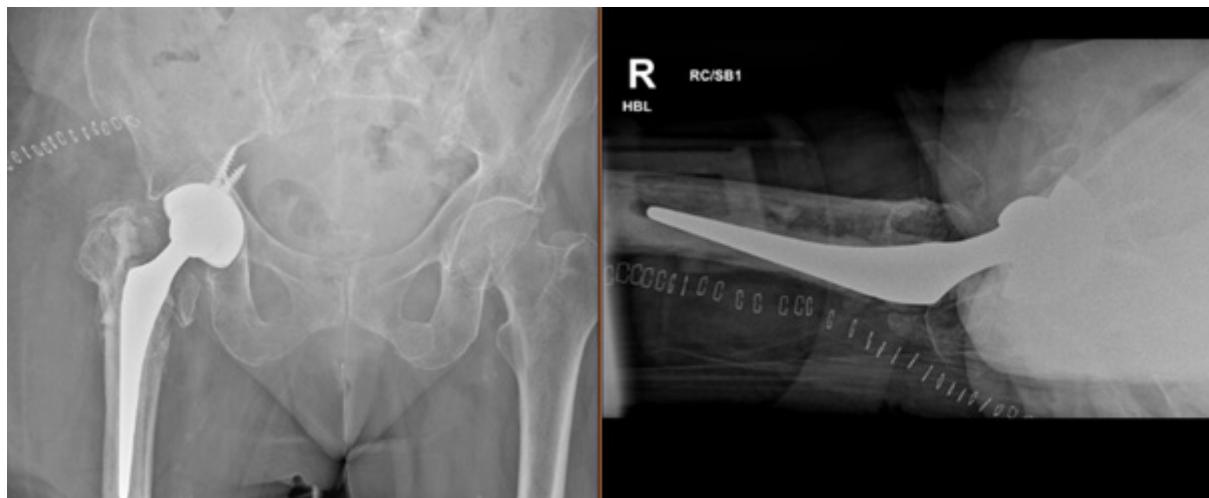
Figure 7: AP and lateral radiographs following revision dual mobility total hip replacement
